## Water Quality Research in Kavresthali Ward 6 July 2016

By: Morgan Mercer

Environment and Conservation Internship  
June and July 2016

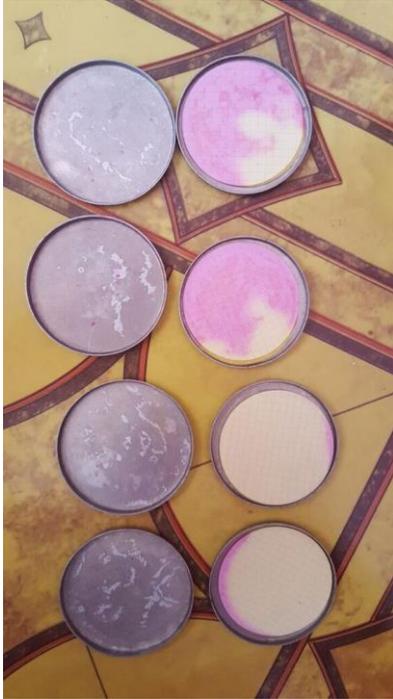
Image 3: 8 July tests

In the pictures below, yellow denotes the presence of e-coli colonies. The more yellow in a sample, the more e-coli is present in that water sample. The pink color indicates water without e-coli and safe drinking water. The pictures below are also only a few of the biological tests conducted. The pictures below show a series of different samples, including several private taps, public taps, sources, and a water treatment method.

- Sample 1 – Thumka Private Tap 1
- Sample 2 – Thumka Private Tap 2
- Sample 3 – Karkithok Source (after rain)
- Sample 4 – Karkithok Public Tap

It is important to note that the amount of yellow, and thus e-coli, in each sample greatly varies depending on the amount of rain before the tests. In the pictures above, the Kaura source and the Karkithok source are displayed twice, once before and once after a big rainstorm. Both of these tests show that there is an increased amount of e-coli and yellow present in the samples taken a day after a big rainstorm. The more it rained right before a sample was collected, the more e-coli was present in the sample. This proves that more rain leads to more e-coli contamination.

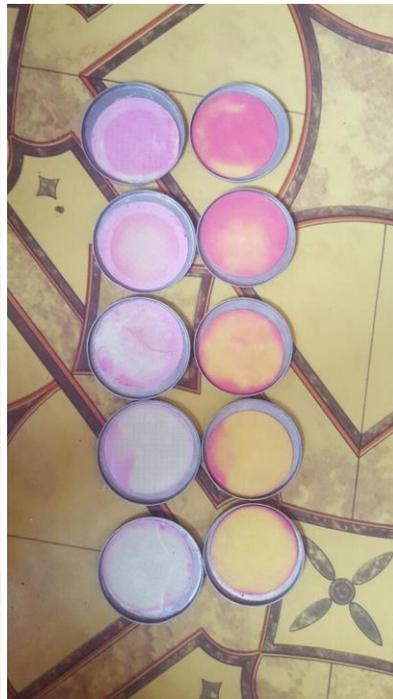
Image 4: 22 July tests

- Sample 1 – Boiled Water
- Sample 2 – Karkithok Source (before big rain)
- Sample 3 – Thumka Public Tap
- Sample 4 – Kaura Source (before big rain)
- Sample 5 – Kaura Public Tap

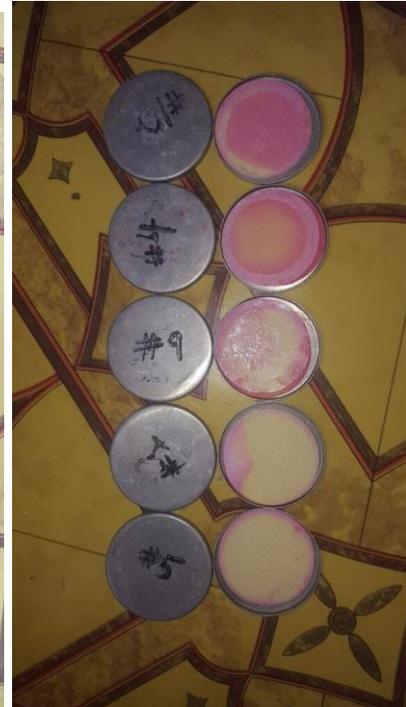
Image 5: 27 July tests

The pictures in Image 5 of the water treatment method also include a test of the tap water before it was filtered. This image shows that there is a significant decrease in the number of e-coli colonies after filtering the water. The same can be seen in Image 4 with the boiled water. The boiled water sample has less yellow in the sample than the other samples present. The small amount of yellow in this sample could be contributed to contamination while handling the sample and not to contamination of the water. Additional tests would be necessary to determine whether the yellow is due to handling the samples or the water itself.

- Sample 10 – Metal Filter (from Michelle’s Tap)
- Sample 4 – Michelle’s Tap
- Sample 9 – Kaura source (after big rain)
- Sample 1 – Kaura Private Tap 1
- Sample 5 – Kaura Private Tap 2

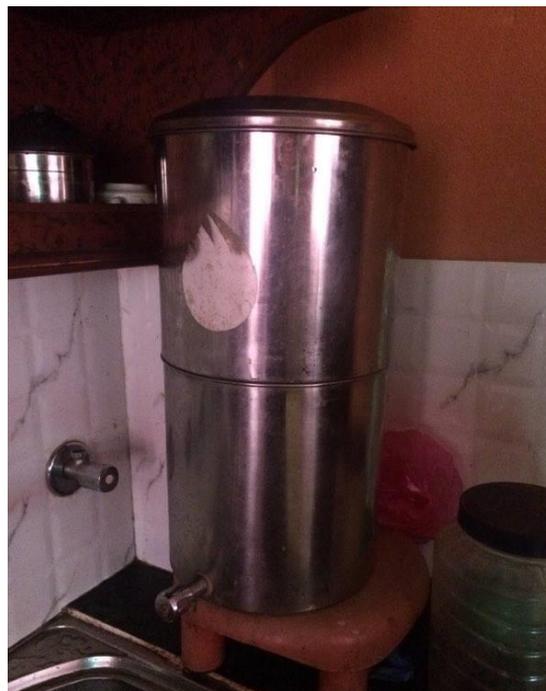
Metal filters were seen in many of the houses during surveys. The most common brand of this filter is a Euro filter, although little else is known about the filters. It was possible to collect water samples from these filters, but none of the families were able to adequately explain how the filter works. Outside of Thumka, where almost every family has a Biosand filter, the most common filtration method is a metal filter.

Image 6: Metal Filter in Michelle's House

The metal filters are able to treat most of the e-coli colonies in the water. The Biosand filter filters out more of the e-coli colonies than the metal filters, but the metal filter still treats the water well. The metal filter's physical and chemical parameters are safely within healthy drinking water standards, and the metal filter is small and does not take up much room in a kitchen or living room.
