Water, Sanitation and Hygiene in Jitpur Phedi, Nepal

Analysis of the current situation concerning water related issues

Final Report – Orientation Internship

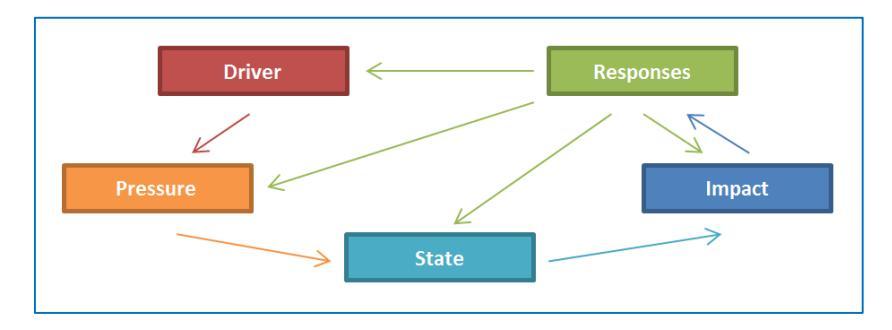
To analyse the causal chain of the situation in Jitpur Phedi the DPSIR-framework is used as a tool. This abbreviation stands for **D**riving Forces – **P**ressures – **S**tate – Impact – **R**esponses. It is used to structure the interplay between the environment and socio-economic activities (Agu, 2007). This approach is utilized to figure out the cause and the cause behind the cause for the problems at the community in order to come up with possible responses in the chapter of recommendations. A schematic drawing of a DPSIR is provided in Figure 4.

Figure 4 Schematic drawing of the DPSIR method

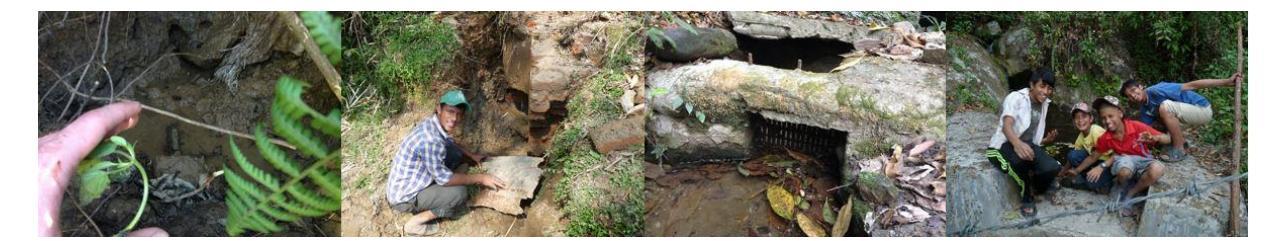
Figure 6 L-R Small and muddy spring; Spring with walls; Start of pipe from a stream; Protected spring

Figure 6 shows different locations from where water is taken. Some sources are very small and turbidity of the transported water can arise already at the beginning as seen in the left picture. That access point can also be easily get stuck with clay or debris.

The picture next to it shows a spring which is protected by a wall of bricks and is also covered on top. In this case the groundwater can access the pipe with a low turbidity and with the least amount of pollution caused over ground.

In the third picture from the left the access point is at a stream. To prevent debris coming into the pipe, a small grid is placed on the access point. In this case the structure was found open with a lot of debris in it which lead to a blocked pipe entrance (figure 7 L). The stream before this access point is at many places shallow and stagnant. In consequence these places are rich in nutrients and the water is warmer which can be beneficiary for bacterial growth (figure 7 M).

The last picture in figure 6 is a protected spring. Walls were built and additionally barbed wire is placed around it to protect the source from trespassing. For some reason this spring is not covered, it is more like a small pond which can easily get polluted. Furthermore there is also a leakage at the bottom of the construction which causes quite some water loss. At the pipe entrance a grid is placed right in front of it to prevent debris from entering the distribution system.

- remove water inlets that are not directly connected to a spring
- fix pipe leakages properly
- remove unused pipes
- clean up water storage tanks and check covers and locks

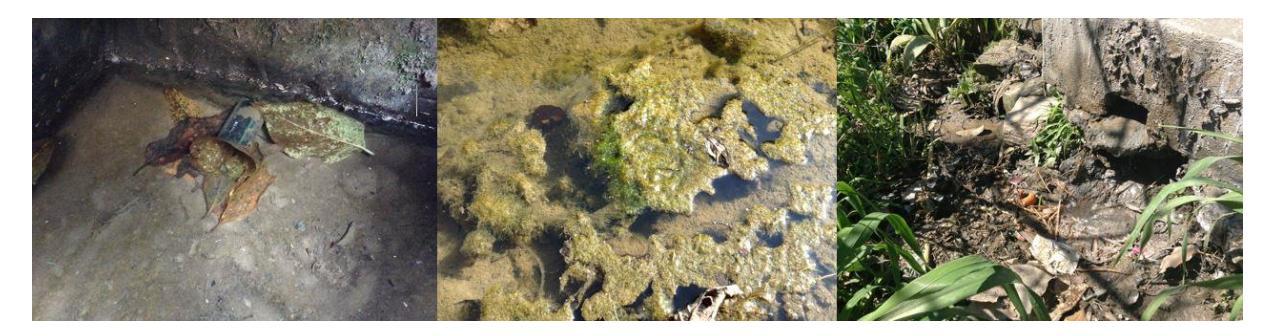
Figure 7 L-R Debris blocks the access point; Stagnant water in the stream; Damaged spring

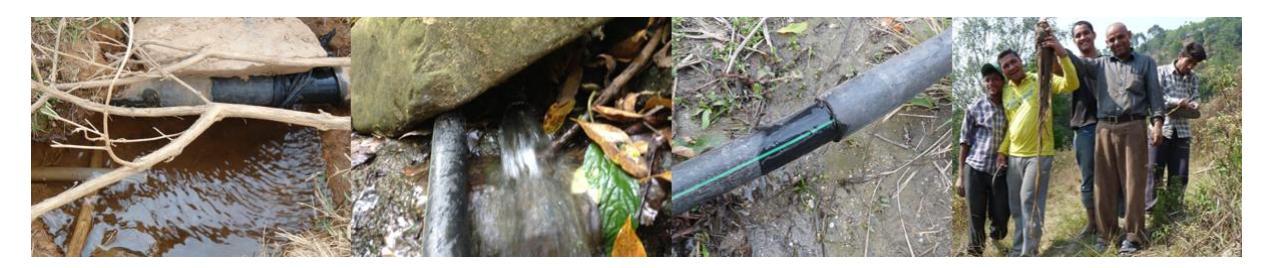
Because there is no authority taking care of the system and the pipes are placed by non-professionals many problems occur over time. First of all a vast amount of pipes is placed over ground along small paths. This makes them vulnerable to damage from the outside and it can happen that they do not keep in place. In consequence the water flow can be disrupted. The most common problem seen in the field are leakages of the pipes which causes a major water loss but also a certain pressure loss.

Figure 8 expresses the most common problems of the pipe system. Quite often leakages are discovered but not repaired sufficiently as shown for example in figure 8 L. As visible in that picture it is often fixed with a piece of a plastic bag.

Second picture from the left presents another common problem. Pipe connections can lose their link and then water is not flowing further at all. To solve that people putting stones on the connections, but even this does not guarantee that the parts will stay together. The third picture from the right also shows a leakage at a connection of two pipes. This problem was encountered very often, because no proper sealing is done.

Problems with roots as shown in the right picture can also occur. In this case a group of men (about 15 people) did not receive water at their households anymore. They were searching along the whole connection – from the source to their tap. Several parts of the system had to be dug out and tanks had to be opened. By the end of the day they found the root which was causing the water blockade (see figure 8 R). They were surprised by the size, but it was not their first time to take out roots. If they do not find a root they usually find pipes full of sediments and debris.

Figure 8 L-R Broken pipe not sufficiently repaired; Connection between pipes lost; Connection leakage; Pipe blocked by roots

Water loss within the network is greatly impacted by lacks but also by random disconnects. This happens because links between pipes are over ground and not often properly fixed. Thus, the links often loosening. During the investigations one sedimentation tank was found in Jitpur Phedi. It only serves at one out of many pipelines and is not as useful as it could be because of pollution that happens afterwards. The majority of the water storage tanks observed would need a cleaning. Solids and debris have accumulated over the years and are a constant supply of nutrients for microorganisms and macro invertebrates.

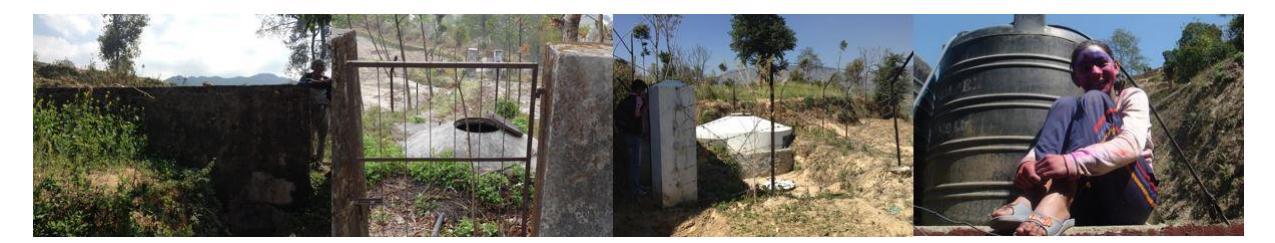
Figure 9 shows the most common designs of water storage tanks. Especially the private water storage tanks can be seen everywhere in Nepal, although in different sizes (see figure 9 R). They are painted black mainly to block most of the light from the inside. This is important because algae and bacteria growth need to be under control. For the big tanks white is a more suitable colour (see figure 9 - 3rd from the L) – the concrete walls are thick enough

Figure 9 L-R Big brick water storage tank 13000L; Old cylindrical concrete tank 5000L; New cylindrical concrete tank 5000L; Private water storage tank 500L

to block the light from the outside. The white colour will reflect most of the light so that the tank is not heating up as fast as it would with a black painting. This is of importance because bacteria grow faster in a warm environment.

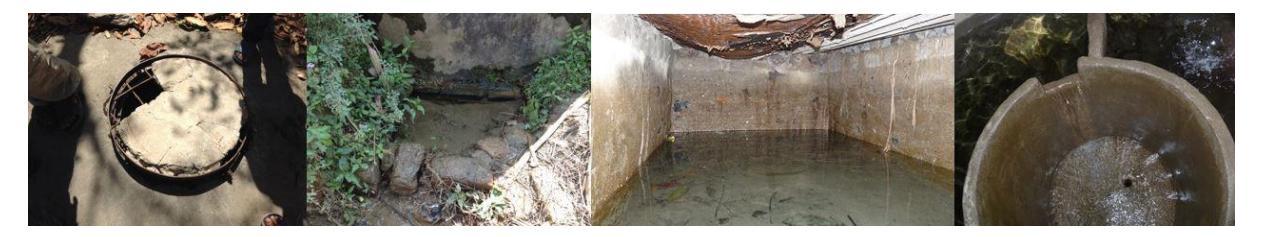
Figure 10 L-R Damaged tank cover; Leakage at tank; Inside a tank; Settling tank

Several deficits for the water tanks were encountered. First of all the big water storage tanks often have been found open. The main reason therefore is that people often check if the reason that they do not have water is because the tank is empty. After opening the tank the people are not aware of the fact that they have to close it again. This causes debris and other pollutants entering the water storage tank (see figure $10 - 3^{rd}$ picture from the L). Moreover, when light comes into the tank organisms such as algae can grow and provide organic material to other organisms. Also in some cases the cover is simply damaged as shown in the picture on the left.

As it is an issue for earlier steps in the distribution chain, leakage happens at some water storage tanks as well (see figure 10 - 2nd from the L). Leakage has been discovered only at old tanks.

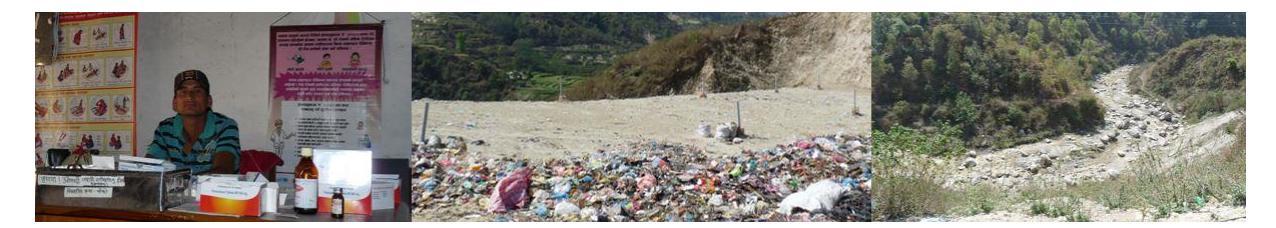
Figure 19 L-R Volunteer at local health post; (uncontrolled) landfill gas venting; River along the dumping site

The danger is not only the pullulated soil and polluted groundwater but also that toxic (liquid) waste can end up in the main river which is right next to it and supplies people and nature downstream. Apart from the environmental damage, people who are working there day for day, get injuries on a regular bases and have a wide range of health problems which the local health post cannot fully cope with. These people are working there to scavenge any resources that might be of value for themselves or for the purpose of selling it to others. During the work they do not wear any protection which makes them vulnerable to toxicants, any kind of sharp materials and medical waste such as used syringes. Among these people are also children, old people and their animals.

- extend campaigns for garbage disposal
